# Field Service Bulletin

FSB 18-04-16-01 REV18-04-019

**Date:** April 16, 2018 **REVISION April 19, 2018****Subject File:** 2018 Kenworth and Peterbilt – ECM Issues**Product:** ECM Telemetry Causing Issues – Applies to all Locators and GPS Boxes and Cable – WT0147 VIC J1939 Type 2 Threaded (SKU: 03-09-0226-00.1)**Author:** Richard McIntyre <Richard.McIntyre@bsmtechnologies.com>

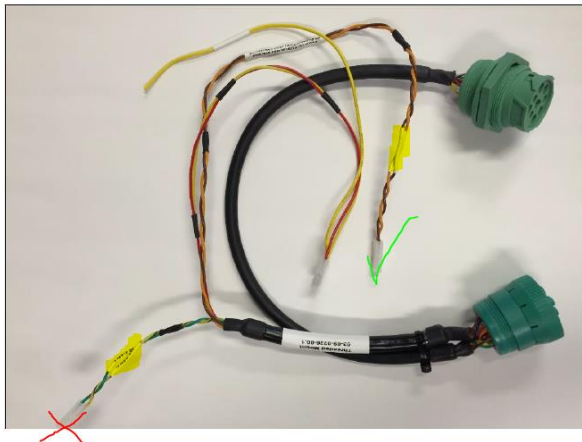
### WT0147 (J1939 Type 2 Threaded)

**Do NOT connect to pins C&D** (High Speed CAN BUS) on the Tractors Green Type II J-1939 Deutsche connector (Data Port).

Connecting to the High speed CAN-BUS (pins C&D of the 9 pin Deutsche connector) may cause transmission fault codes that would randomly cause the truck to go into limp mode. In addition, odometer is not available of pins C&D.

On 2018+ Kenworth and Peterbilt. CONNECT the **VIC's** ECM pair labeled **Pin F** and **Pin G**, the orange and brown ECM pair.

For all 2018+ Kenworth and Peterbilt that have been connected to date instruct clients that are self installer, to change the connection to ECM pair labeled as **Pin F** and **Pin G** (from it is recommended configure Locator or GPS Box to disable all ECM activity. Inform client in advance if HOS, they'll need to instruct their drivers to go to paper logs. For all clients that are installed by BSM Field Service Team will work through these.
